**MT-RAP-2008-00100/mso**

**Summary of coating surveys  
on the four air command frigates  
(Zeven Provinciën class)**

Date	March 26, 2008
Author	R. van der Kaaden, B.Sc. (TNO Quality Services B.V.)
Client	Ministry of Defence DMO / DWS / RZS / PLTFT Corrosion Prevention Attn. of Mr. H. Bakuwel, B.Sc. MPC 58 A P.O. Box 90822 2509 LV The Hague
Classification report	Unclassified
Classified by	H. Bakuwel, B.Sc.
Classification date	March 12, 2008
Title	Unclassified
Managementuittreksel	Unclassified
Abstract	Unclassified
Report text	Unclassified
Appendices	Unclassified
Copy no	18
No. of copies	22
Number of pages	40
Number of appendices	1

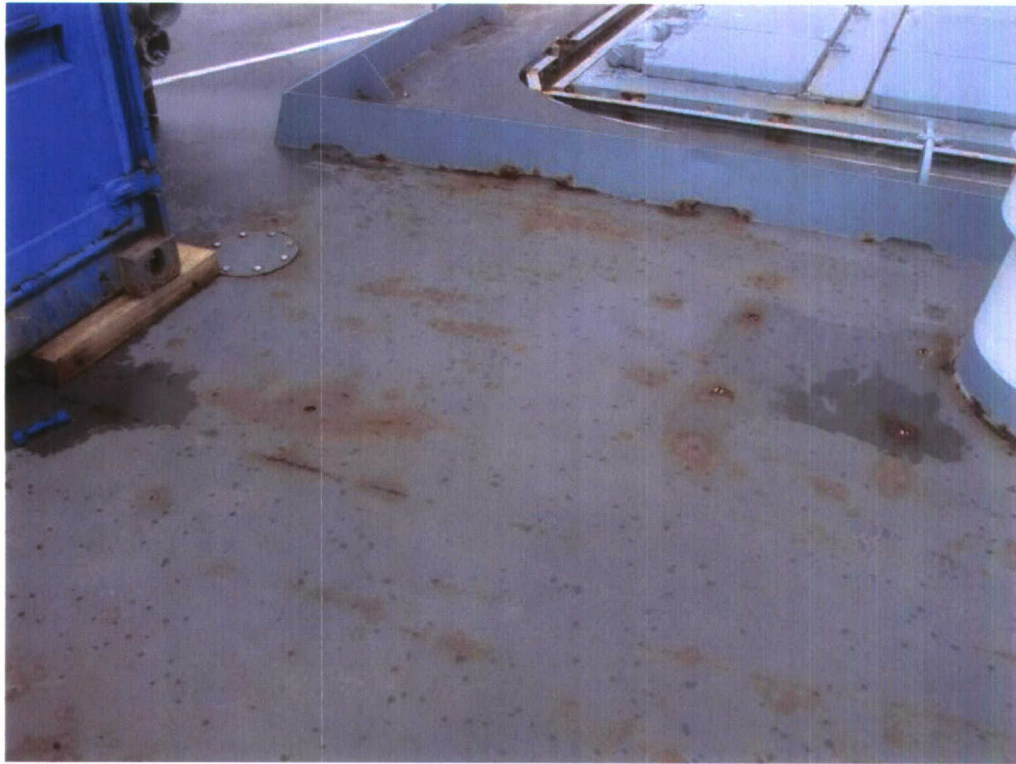
Photo 27: Hr.Ms. "Zeven Provinciën" (LCF 1). Deck (25.06.2007).  
F deck, PS forward. Corroded spots and cracks in deck covering.

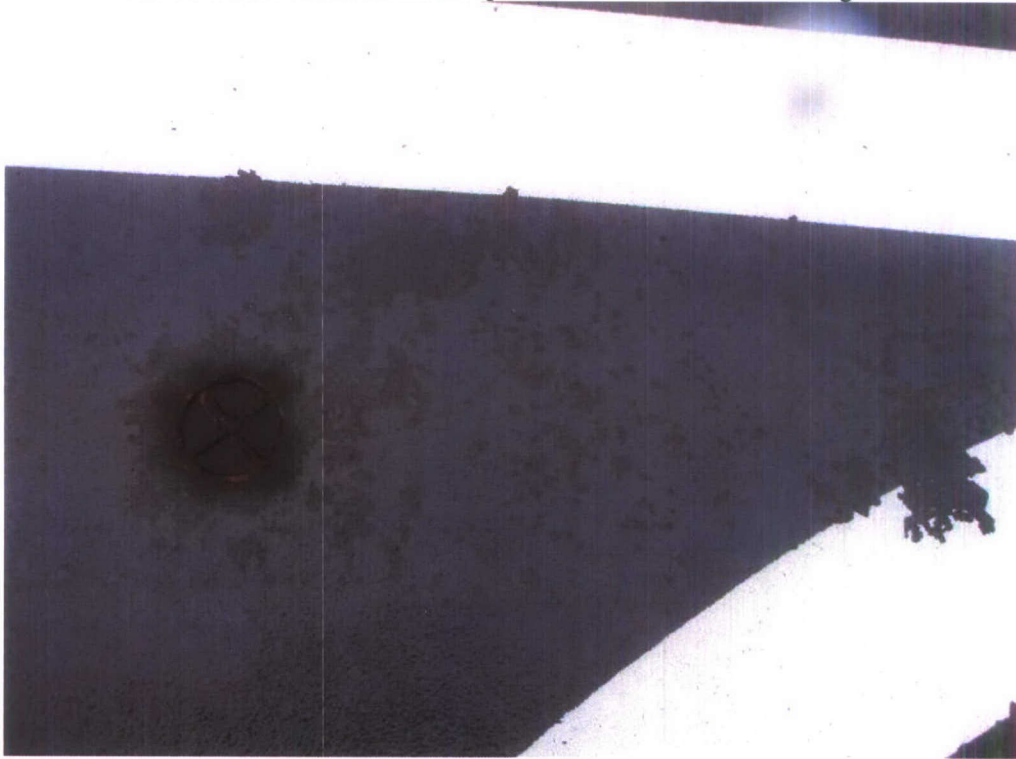
Photo 28: Hr.Ms. "Zeven Provinciën" (LCF 1). Deck (25.06.2007).  
G deck. Detachment of topcoat and corrosion of lashing point.

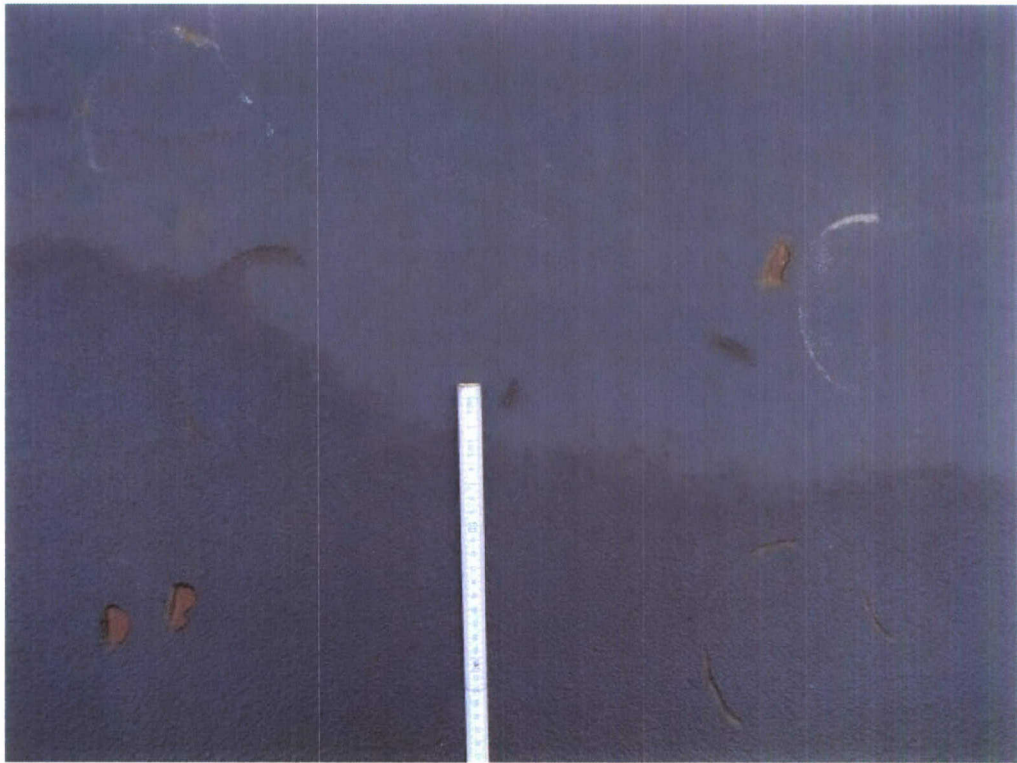
Photo 29: Hr.Ms. "Tromp" (LCF 2). Deck (04.08.2006).  
F deck. PS forward. Damages caused by falling ammunition.

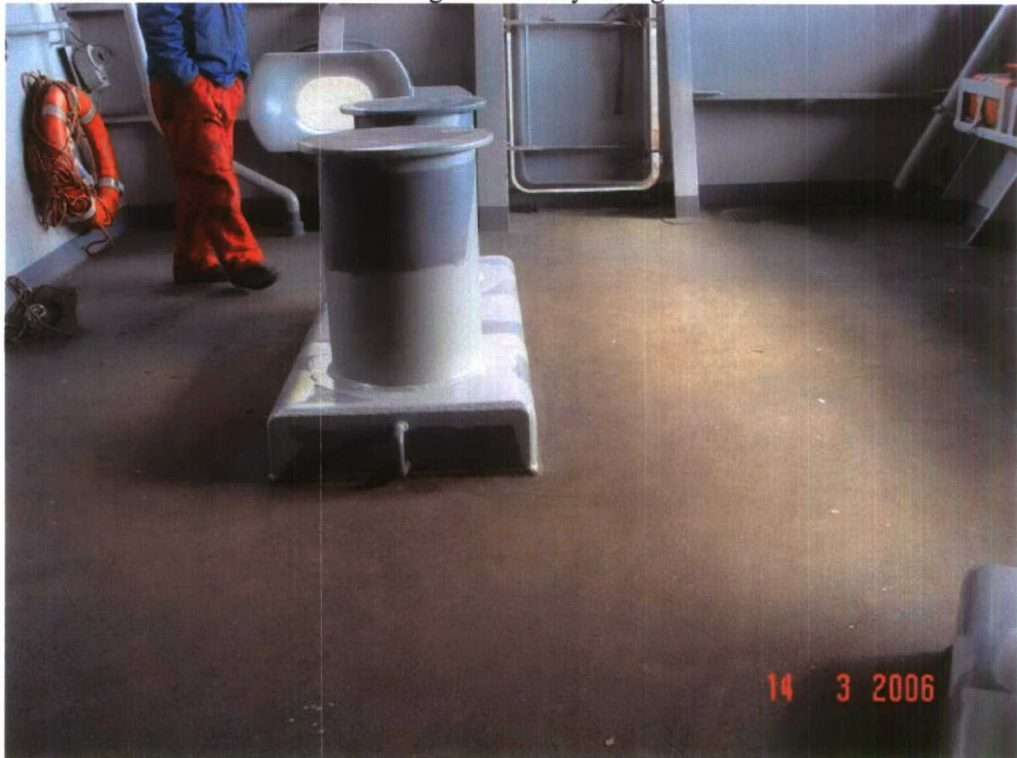
Photo 30: Hr.Ms. "Evertsen" (LCF4). Deck (14.03.2006).  
H deck. Dirty surface.
